CAMDEN COUNCIL PUBLIC EXHIBITION DOCUMENT 2022

REVIEW OF UPPER SOUTH CREEK FLOOD STUDY IN THE CONTEXT OF ONGOING DEVELOPMENT: APPENDIX B – FLOOD MARKS SURVEY REPORT FOR FEBRUARY 2020 FLOOD EVENT

(Draft Report)

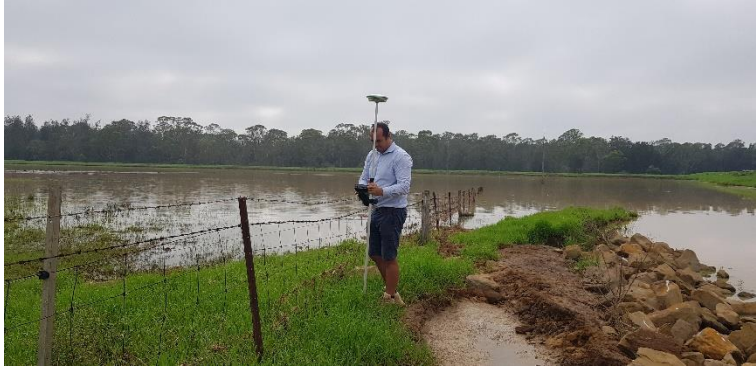
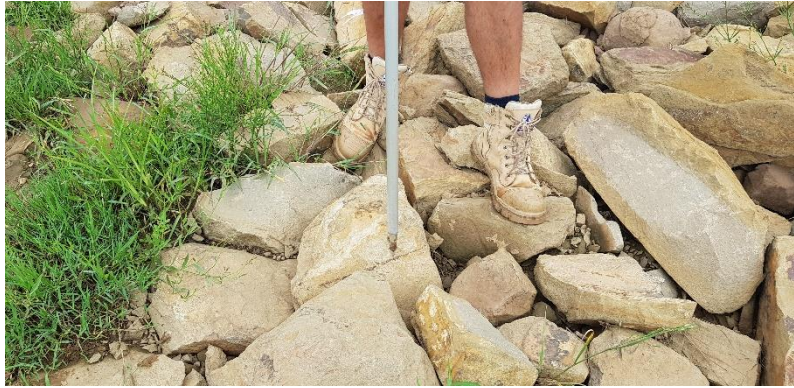
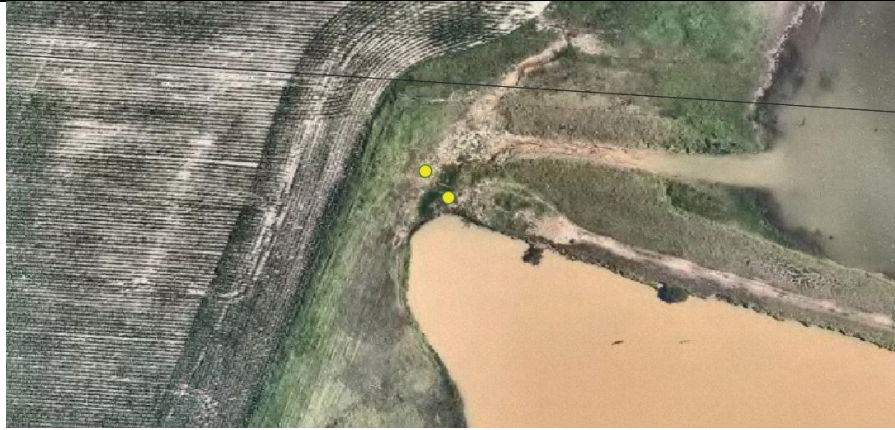
| Point # | Location | Photographs | | |
|---|---|---|--|--|
| 3.03 & 3.04 | DAM No.2 | | | |

| Point Number | Easting | Northing | Elevation | Description |
|---|---|---|---|---|
| 3.03 | E 292298.196 | N 6237693.382 | RL 73.75 | Weir Level |
| 3.04 | E 292293.553 | N 6237698.553 | RL 73.75 | Debris mark on spillway |
