# CAMDEN COUNCIL PUBLIC EXHIBITION DOCUMENT 2022

## REVIEW OF UPPER SOUTH CREEK FLOOD STUDY IN THE CONTEXT OF ONGOING DEVELOPMENT: APPENDIX B – FLOOD MARKS SURVEY REPORT FOR JUNE 2016 FLOOD EVENT

(Draft Report)

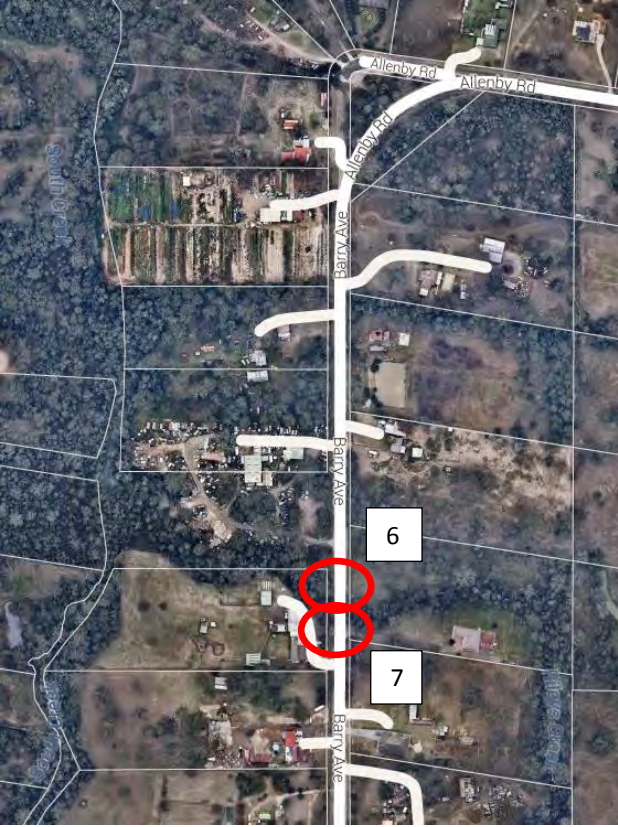
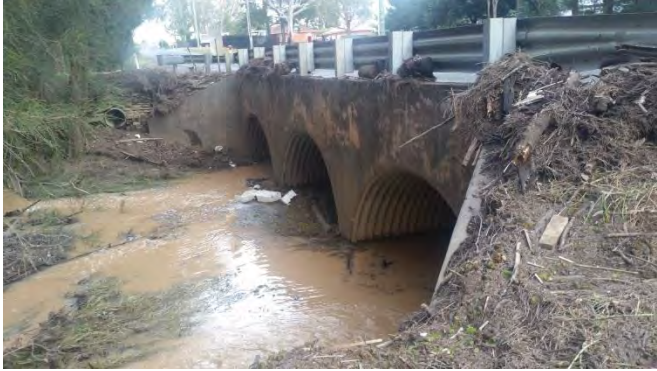
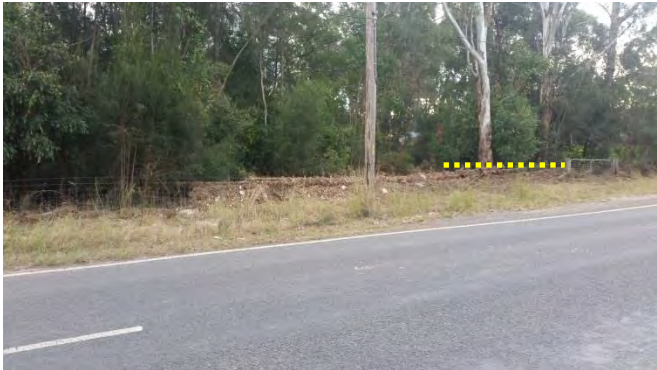
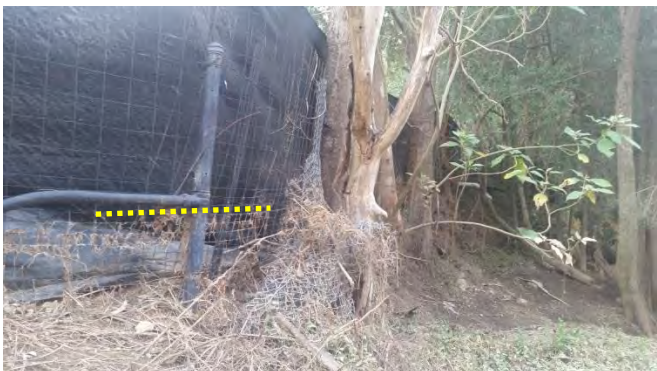
| Location | Photos | Comments |
|---|---|--|
| <p data-bbox="96 156 680 220"><b>5. Rileys Creek – Barry Avenue Culvert (Catherine Field)</b></p> | | <ul style="list-style-type: none"><li>• Riley's Creek broke its banks and flowed over Barry Avenue</li><li>• Flood debris marks were taken from the downstream side of Barry Avenue, both to the north and south of Rileys Creek</li><li>• <b>Flood Level 6 = 62.051 m AHD</b></li><li>• <b>Flood Level 7 = 62.347 m AHD</b></li></ul> |
